11. TITLE (Include Security Classification) Rehabilitation of Navigation Lock Walls: Case Histories					
12. PERSONAL AUTHOR(S) McDonald, James E.					
13a. TYPE OF REPORT Final Report	13b. TIME COVERED FROM TO	14. DATE OF REPORT (Year, Month, Day) December 1987		15. PAGE COUNT 316

means for removing large quantities of concrete. Once the deteriorated concrete has been removed, conventional cast-in-place concrete has been used as the replacement material in most lock wall rehabilitation projects. Other replacement systems that have been used or proposed include shotcrete, preplaced-aggregate concrete, and precast concrete stay-in-place forms. In addition, several materials including latex-modified concrete, polymer mortars and grouts, conventional shotcrete, and latex-modified, fiber-reinforced shotcrete have been used as thin overlays on existing lock walls. Applications of the various rehabilitation systems and their performance to date are described in selected case histories.

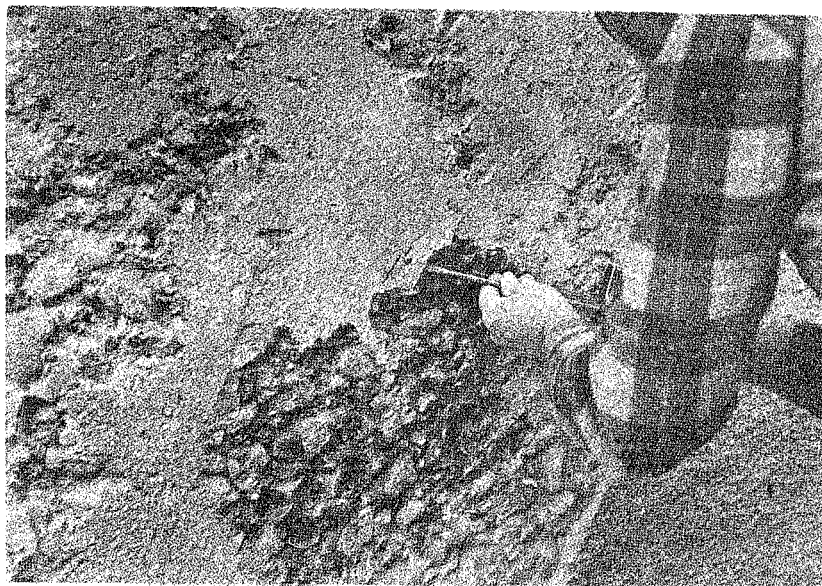
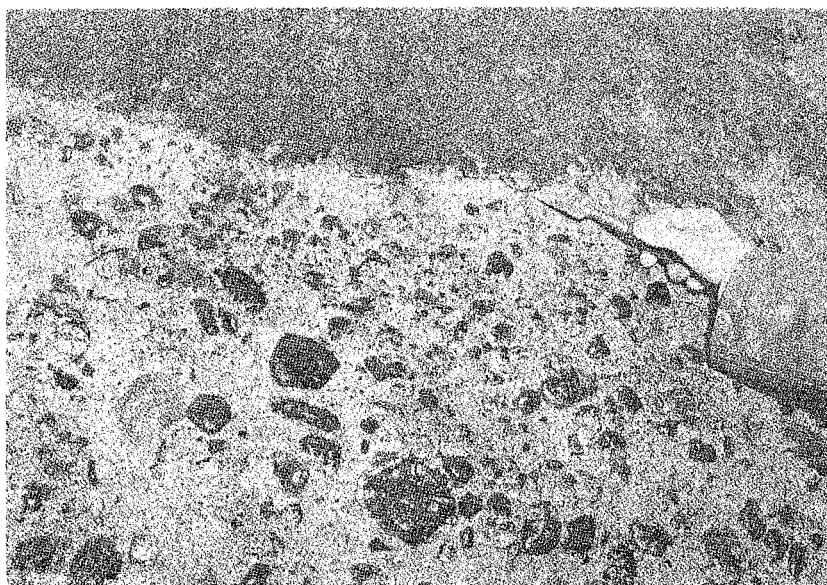
Figure 113. Examples of how easily the unsound surface mortar could be removed, Lower Monumental Lock

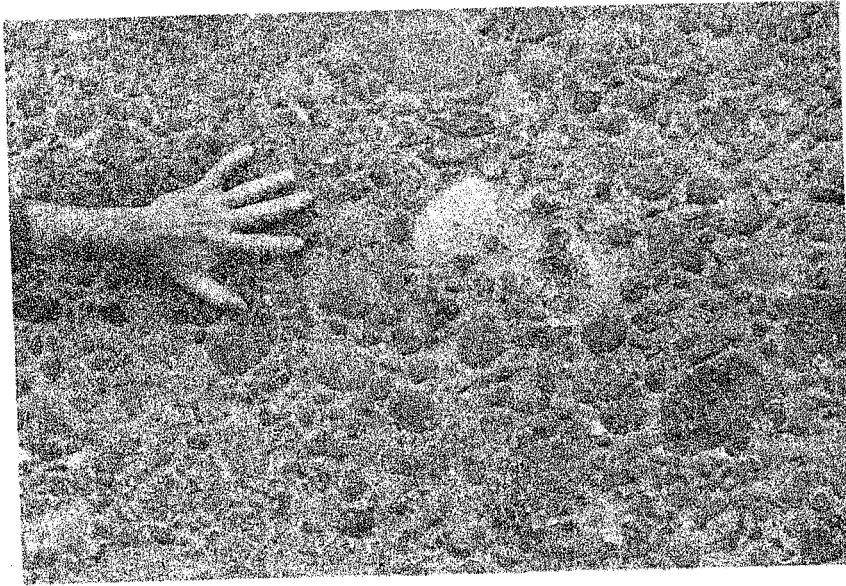
Figure 114. Typical condition of the wall following acceptable surface preparation, Lower Monumental Lock

259. Most of the actual cleaning was done between lockages over a three-week period before the lock outage and actual spray-up coating operations began. High-pressure water-jet equipment was used and normally operated at about 10,000 psi. As the nozzle tips would wear out, the pressure would start to drop to about 7,000 psi. New tips were then installed. Both the pressure and angle of the jet were critical to effectively remove unsound materials. Occasional handchipping was used to supplement the water jet in areas where it just did not clean well enough. Usually the unsound mortar was about 1/4- to 3/8-in. thick and flaked off easily (Figure 113). For most of the area in the lower portion of the lock, scaling had already occurred to a depth of 1/2 to 2 in. in the mortar, severely exposing the large aggregate which itself was quite sound. An example of the wall surface after acceptable surface preparation is shown in Figure 114.

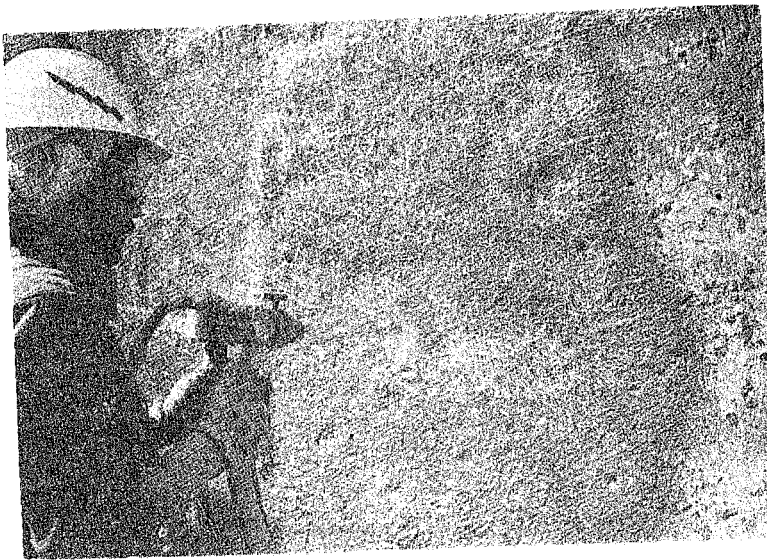
266. As the work progressed from the upper lifts which had less deterioration (Figure 117) to the lower lifts with substantial deterioration, the length of fiber used had to be adjusted. The cutter heads were designed to chop fibers of 1-1/2-, 4-1/2-, or a combination of 1-1/2- with 3-in. lengths. The longer fibers were desired because of their believed tendency to give greater toughness and strain capacity. However, where the depth of relief around large exposed aggregate was about 1/2 in. or more, the long fibers tended to bridge across adjacent pieces of aggregate leaving an air void over the relief between them. Where a combination of 1-1/2- with 3-in. fibers was used, this problem was minimized.

Figure 117. Coating application in an area of minimal scaling near the top of the lock, Lower Monumental Lock

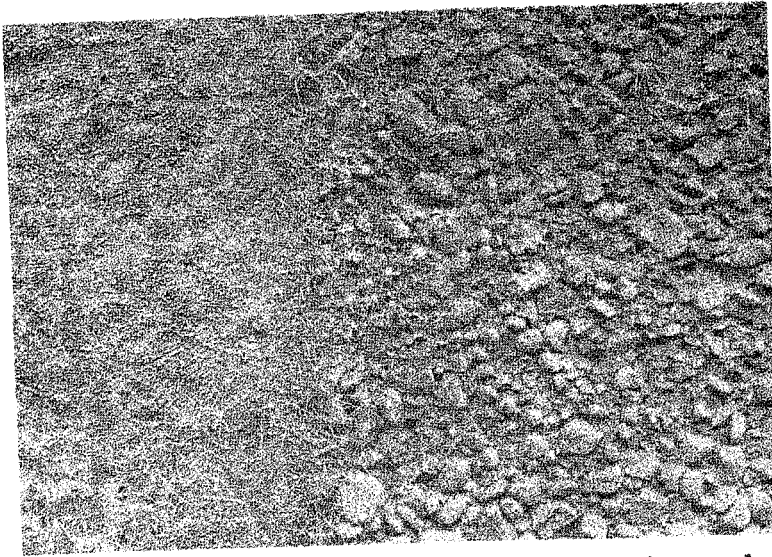
a. Coating of rough, severely deteriorated concrete

268. The thickness of the in-place coating (Figure 118) varied between 5/16 and 5/8 in. and averaged 3/8 in. In areas where 3-in. aggregate was visible on the lock wall, the thickness over the outside of the 3-in. cobbles was less than 3/8 in., but between the aggregate particles it was more than 3/8 in. Since protection over the mortar between the aggregate was most important, this thickness was considered acceptable. Thickness was continuously checked by stabbing the wet mix with a nail used as a depth gage.

Figure 118. Typical appearance of the wall coating, Lower Monumental Lock

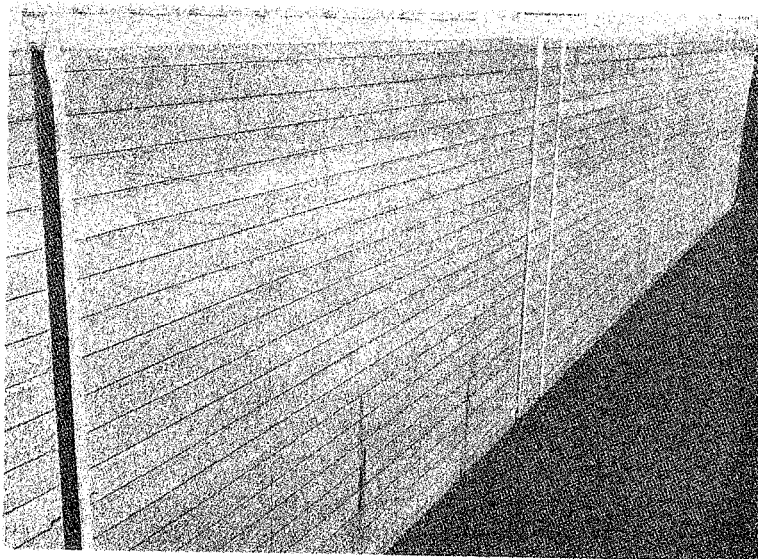
a. Overall view of north wall

270. After about six months in service, the coating appeared to be in good condition as shown in Figure 119. During the June 1981 lock outage, approximately one year after the coating was applied, the lock walls were evaluated by soundings, visual examination, and core drilling. Based on soundings at a typical 45-ft wide by 100-ft high section of monolith 15, it was concluded that 99.2 percent of the coating was fully bonded. About 20 unbonded areas were found. Generally, the unbonded areas were about 1 sq ft or less in area and located just below a lift joint or adjacent to a monolith joint. These unbonded areas were attributed to the fact that the workmen who applied the coating had a natural tendency to underspray or underroll near lift joints. Also, because of the nature of the coating material, it usually would pull loose or slough near monolith joints when it was trimmed to maintain the joint line. It would then be rerolled as best as was practical, but apparently this procedure was not totally effective.

Figure 119. Condition of the coating after about six months in service, Lower Monumental Lock

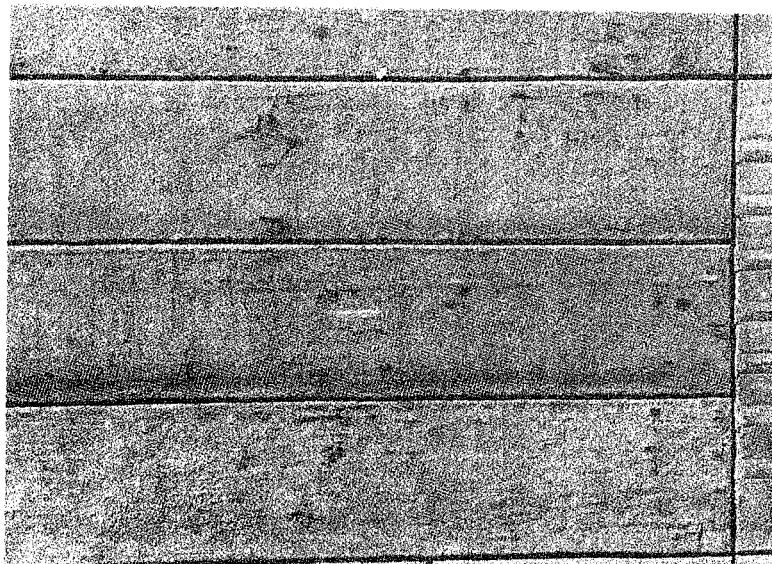
b. Evidence of barge impact on the coating

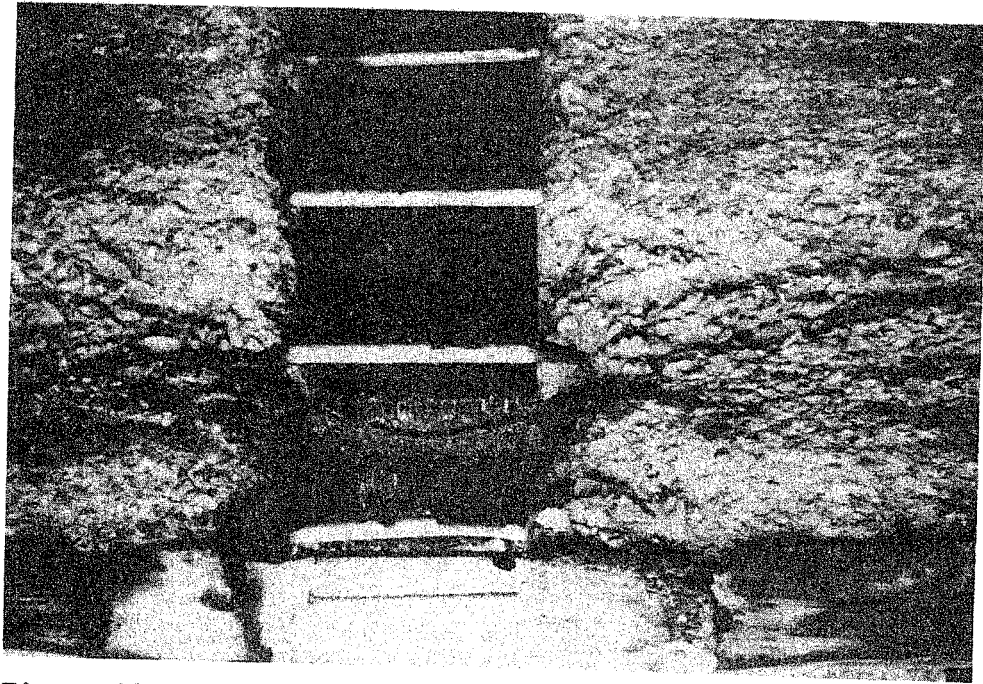
Figure 121. Typical concrete deterioration in upstream guide wall, 1980, Emsworth Locks

284. In November 1980, a demonstration repair was conducted at Emsworth Locks to evaluate the potential of steel fiber-reinforced shotcrete as a repair material. A section of the original upstream guide wall (Figure 121) was cleaned with a high-pressure water jet, and one monolith joint was chipped out in a vee shape to a depth of approximately 6 in. (Figure 122). A strip of joint filler board was placed in the vee joint prior to shotcreting. A dry mix of Fibercrete (sand, cement, and steel fibers) in 60-lb bags was hand-fed into a hopper at a rate of 2 to 3 bags per minute. The 1-in. long steel fibers with hooked ends were 2 percent by weight of the Fibercrete mixture. Water was added at the nozzle via a connection with the local water system. The vee joint was completely filled, and 1 to 2 in. of Fibercrete was placed over the remainder of the test section (Figure 123). Rebound was estimated at less than 10 percent. Although not done for the test section, a striker could be used to shave the wall after it was shotcreted to obtain a smooth surface.

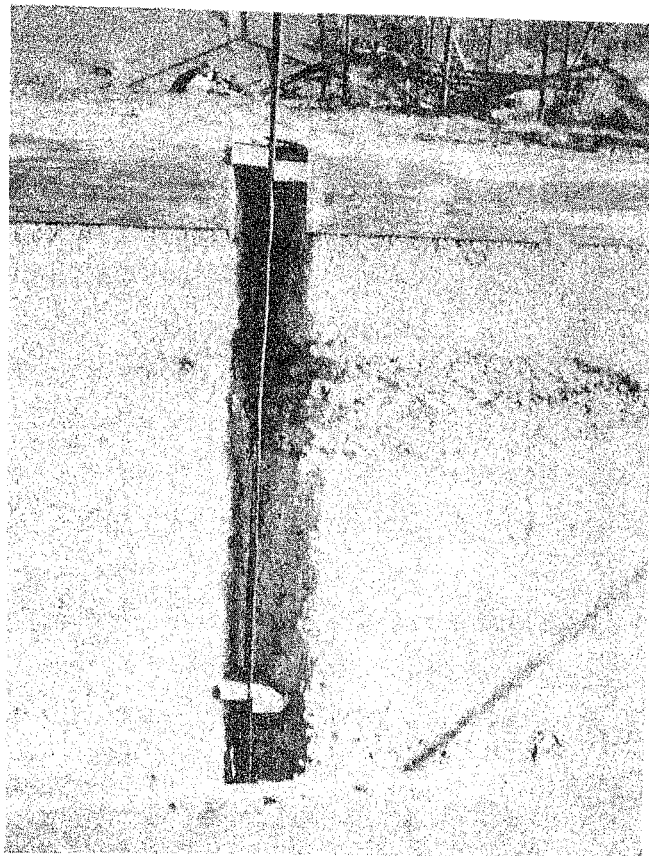
Figure 122. A portion of the prepared test section prior to Fibercrete application, November 1980, Emsworth Locks

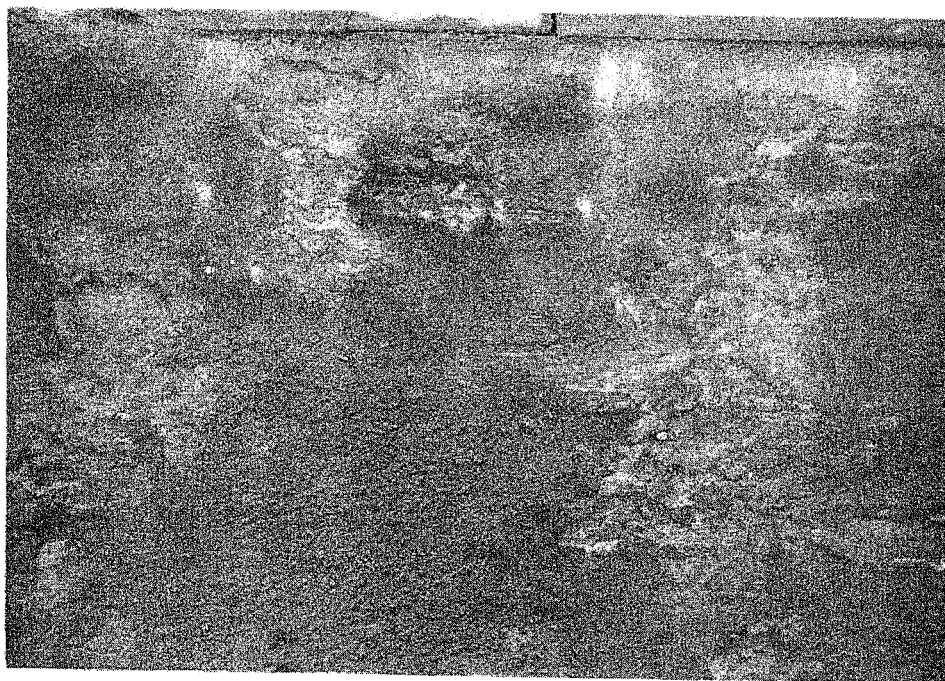
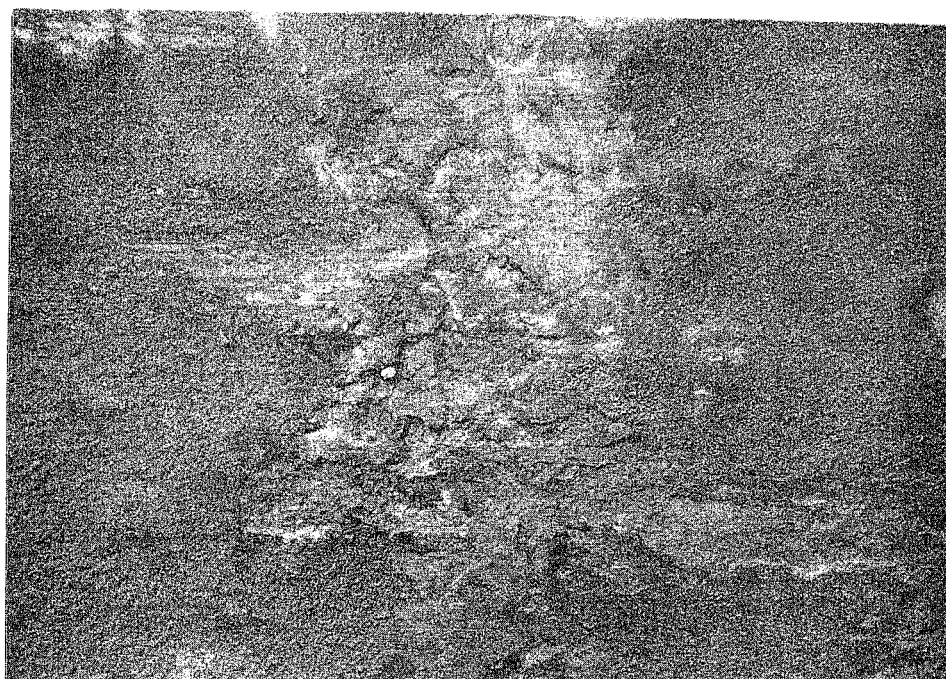
286. A tour of the Emsworth project was made in February 1981 by HQUSACE, Division, District, and WES representatives to examine the condition of the structures, including the Fibercrete test section. After three months in service, the Fibercrete exhibited numerous examples of impact failure, abrasion erosion, and delamination (Figure 124). The explanation for the poor performance of the Fibercrete was that the prepackaged mixture used in the demonstration contained only 60 lb/cu yd of fibers, whereas in the actual

Figure 124. Typical examples of Fibercrete condition,  
February 1981, Emsworth Locks

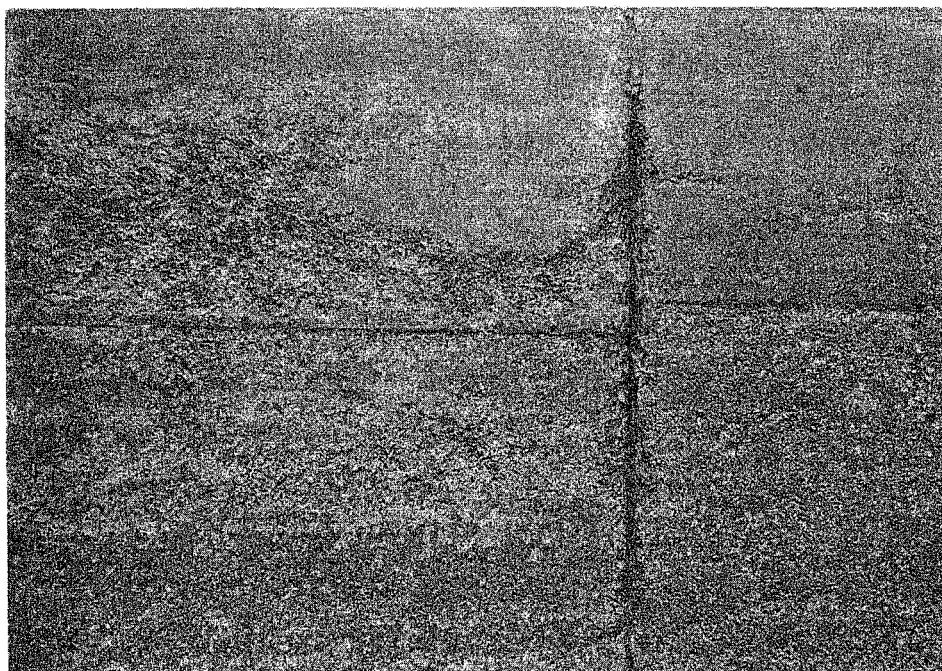
287. Considering that the larger land chamber receives most of the heavy barge traffic and that the nonair-entrained concrete had been in service for approximately 50 years, surfaces of the land lock chamber walls appeared to be in relatively good condition (Figure 125) when inspected in 1981. One exception was the monolith joints (Figures 125 and 126). Concrete and shotcrete in the smaller river chamber appeared to be in more advanced stages of deterioration, particularly the land wall (Figure 127) where the smaller tows and pleasure craft using this chamber tie up. Spalling appeared to have originated in the upper portion of the wall where the shotcrete was relatively thin and surface preparation minimal. Spalling propagated down the wall to the point where shotcrete thickness (approximately 4 in.) was sufficient to contain dowels and wire mesh (Figure 128). In comparison, the shotcrete on the river wall of the smaller chamber appeared to be in much better condition (Figure 129). Fifty to seventy percent of the existing shotcrete in the river chamber was reported as "drummy" when sounded.

Figure 125. Typical concrete surfaces, land lock chamber wall, 1981, Emsworth Locks

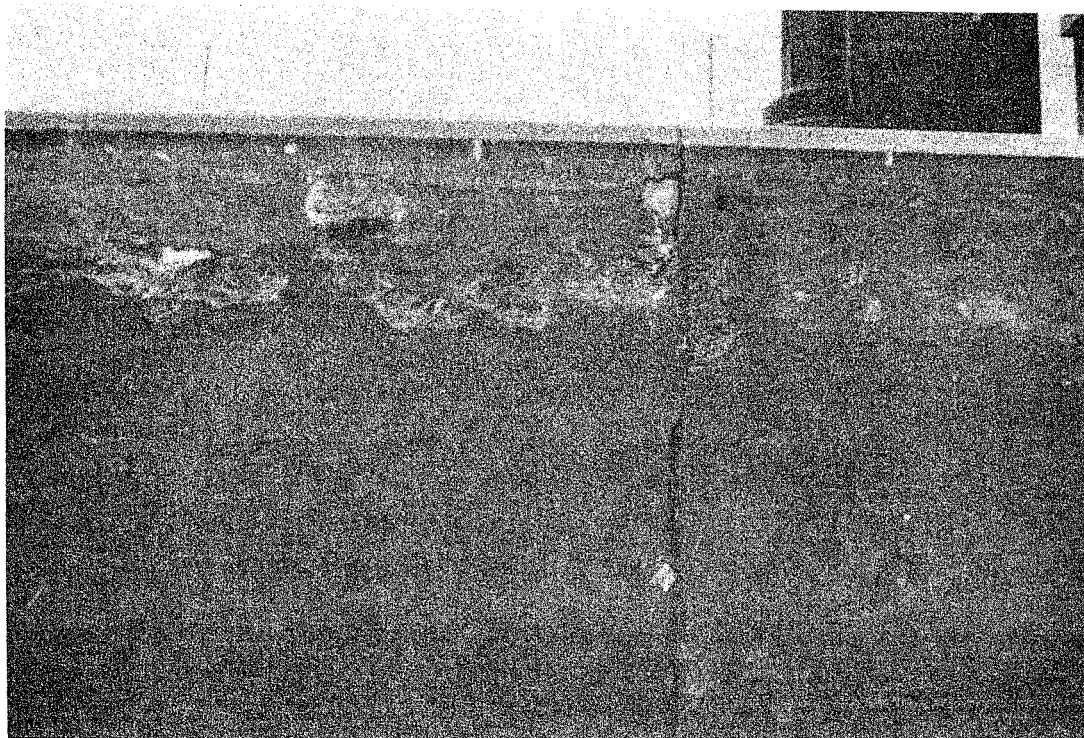
Figure 129. Typical appearance of the river wall in the river lock chamber, 1981, Emsworth Locks

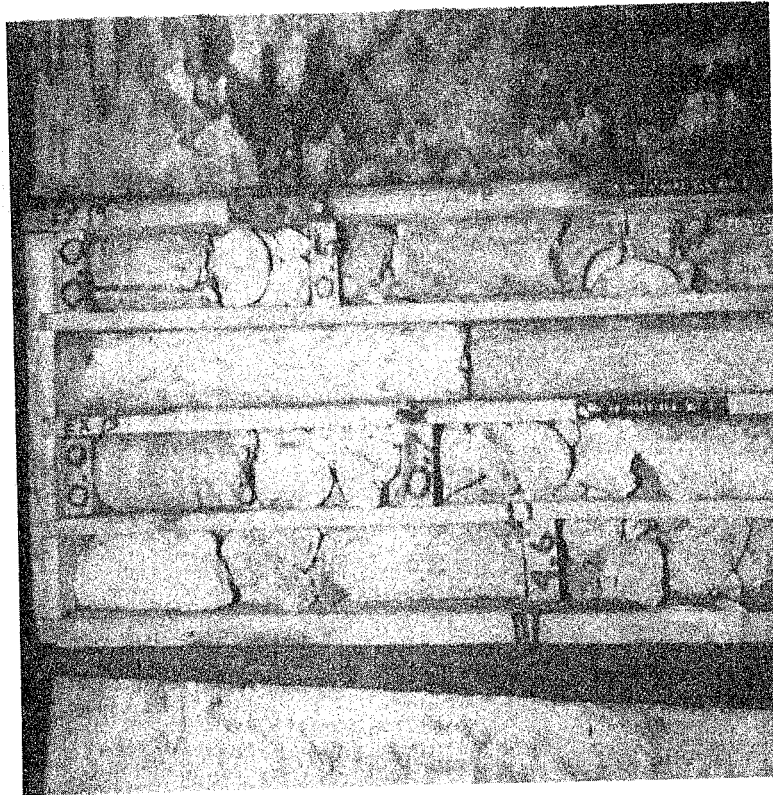
Hole No.  
EX-13

288. During this inspection, horizontal cores drilled from the lock chamber walls in 1973 were compared. Cores from the river chamber showed the shotcrete to be in generally good condition (Figure 130); however the original concrete behind the shotcrete exhibited significant deterioration probably caused by cycles of freezing and thawing. Cores of similar concrete from the land chamber which were not coated with shotcrete were in generally good condition from the surface inward (Figure 131). These cores appear to be an example of an exterior coating contributing to the saturation of the original concrete with increased deterioration caused by frost action as a result.

Figure 130. Horizontal cores taken from the river chamber walls, 1973, Emsworth Locks

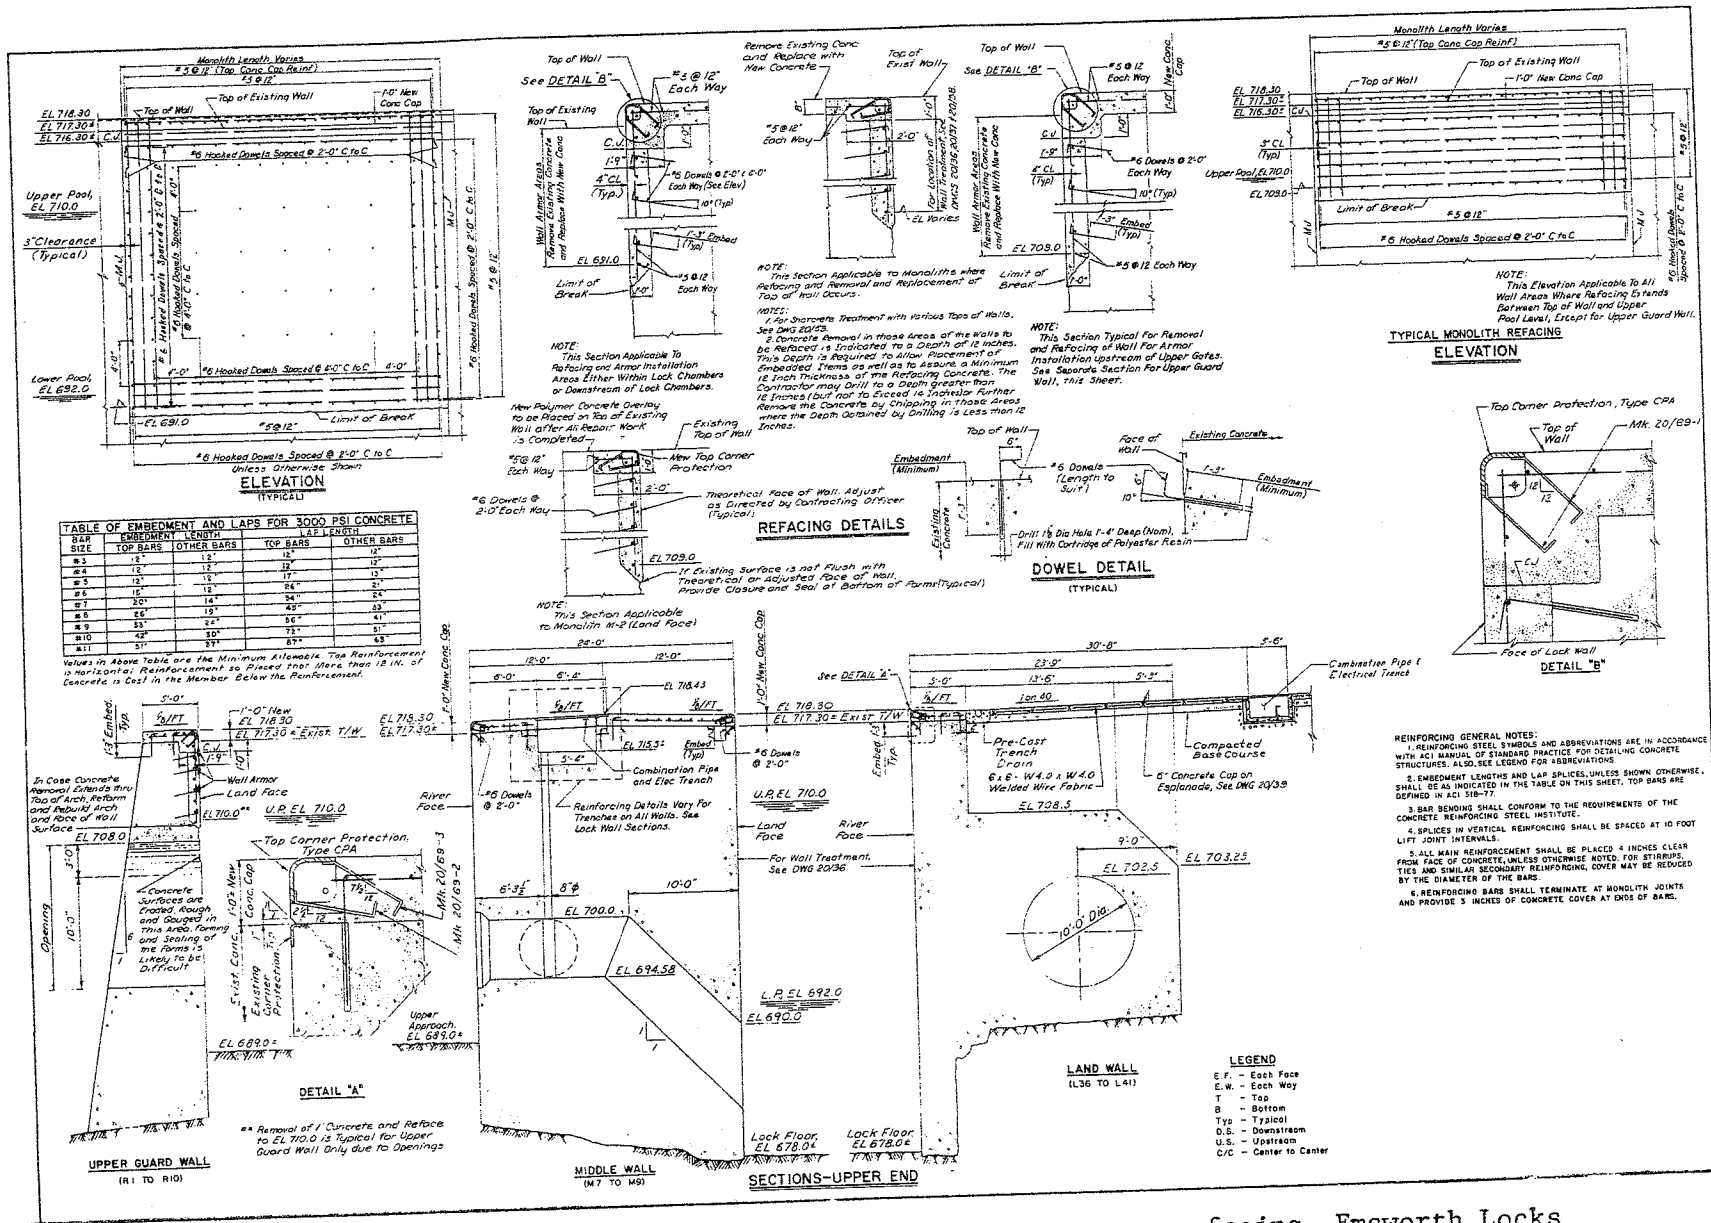
Figure 132. Elevations, lock chamber wall refacing, Emsworth Locks

293. Vertical surfaces of the lock walls were resurfaced with both conventional cast-in-place concrete and shotcrete. Resurfacing within the lock chambers extended from 1 ft below lower pool to the top of the walls. The resurfacing outside the chambers extended from the controlling pool line to the top of the walls. A 12-in. thick overlay of reinforced concrete was placed on top of the lock walls. Details of the various types of repairs are shown in Figures 132-135.

297. A shotcrete coating was applied to selected areas of the lock walls (Figure 132). This coating consisted of layers of shotcrete built up as

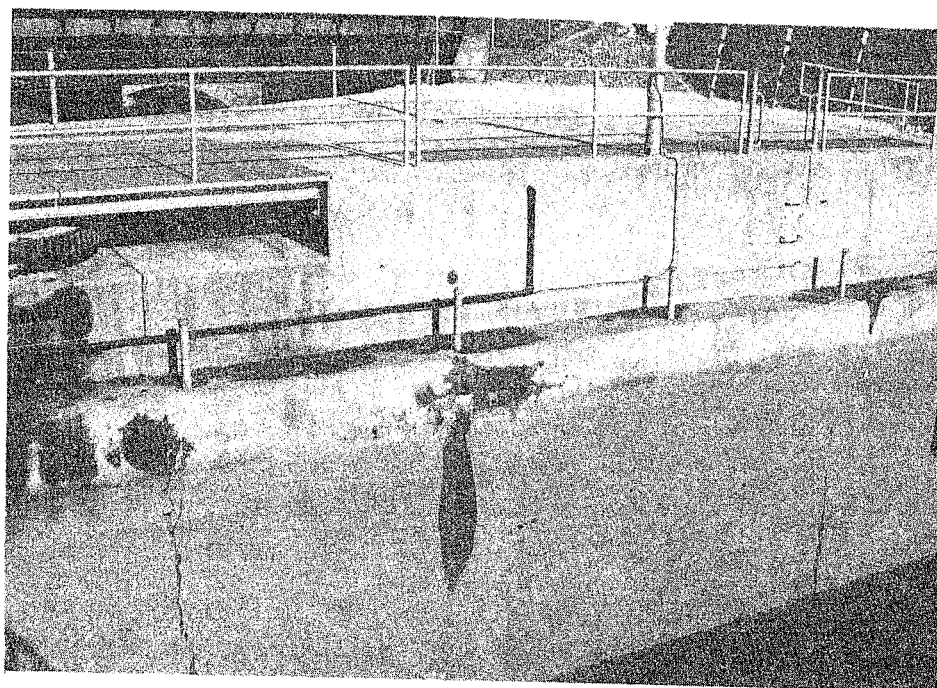
80 percent of the shotcrete coating on monoliths L-37 and L-38 between elevations 692 and 703 was missing to depths of up to 2 in. The coating on monolith L-39 contained a reflective vertical crack which was also present in the concrete below the lower limit of the shotcrete coating. The monolith joint and ladder-way repairs were in good condition. The shotcrete coating applied in the gate recesses was in poor condition with numerous horizontal and diagonal cracks (Figure 136). The majority of these cracks, which ranged in width

Figure 136. Cracking in shotcrete coating, downstream gate recess, land wall, December 1985, Emsworth Locks

from fine to wide, were located above upper pool elevation. According to lock personnel, these cracks occurred almost immediately after shotcreting, perhaps because of the prevailing hot, dry wind at the time of placement. Efflorescence was associated with a number of these cracks. A few cracks were dampened by water, and in several places water seepage through cracks in the coating covered large areas of the coating. Small areas of the shotcrete coating were debonded from the underlying concrete.

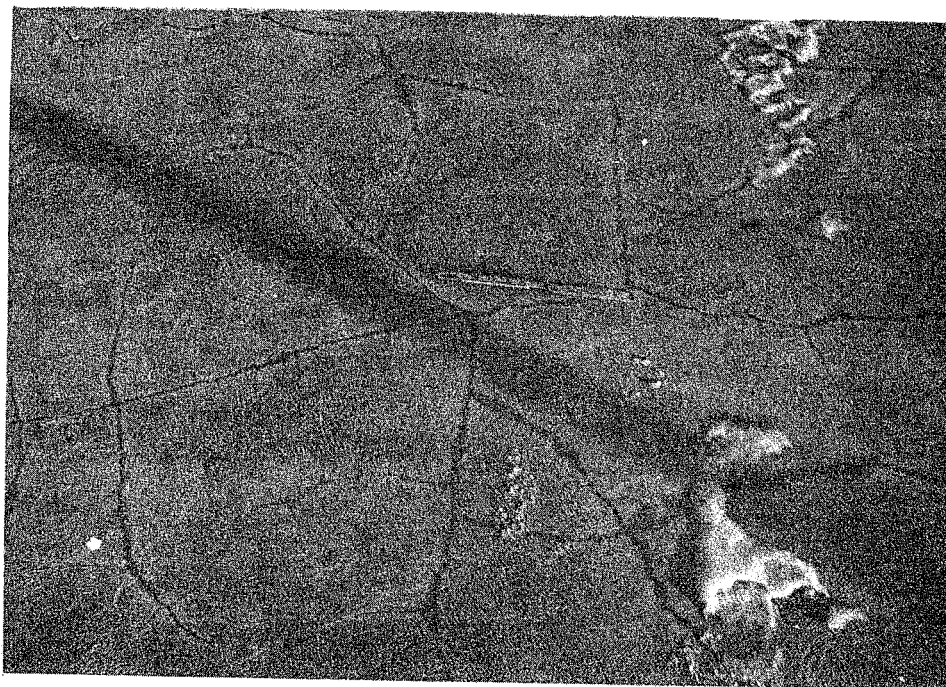
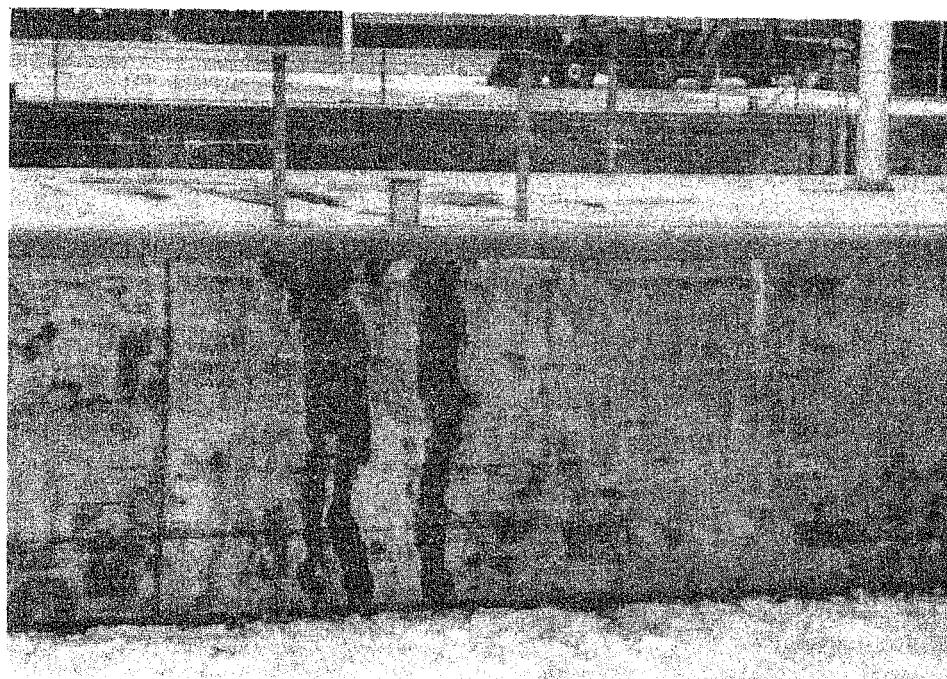
and M-2 was in poor condition with extensive pattern cracking (Figure 137). These cracks allow water ponding on top of the monoliths to infiltrate the underlying concrete as evidenced by water seepage on vertical wall surfaces beneath the corner protection armor. The ladder ways and monolith joints repaired with concrete and shotcrete, respectively, were in good condition.

a. Pattern cracking, top surface

b. Seepage on chamber face as a result of water ponding on top surface

Figure 137. Condition of polymer mortar overlay, monolith M-2, December 1985, Emsworth Locks

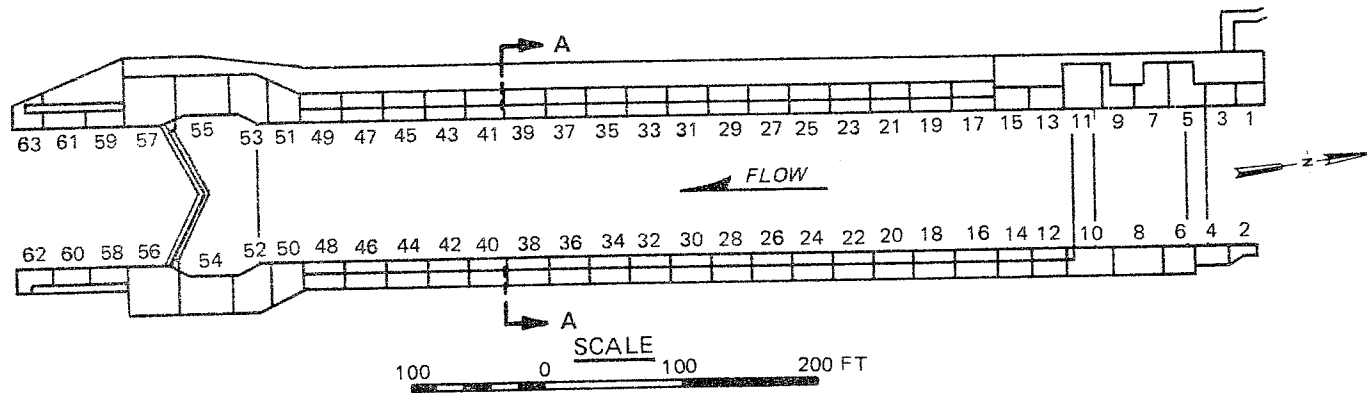
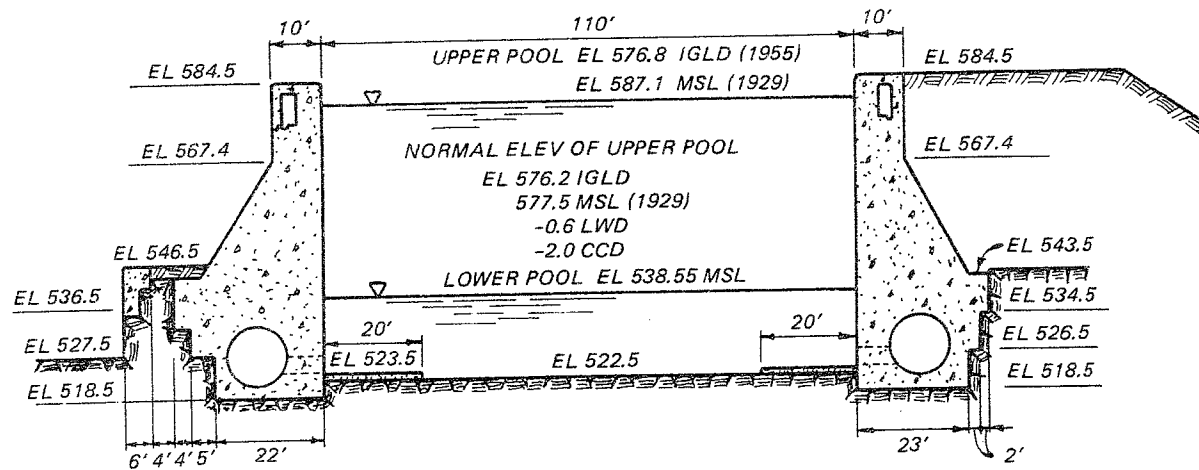
Figure 138. Plan and typical section, Lockport Lock

309. Lockport Lock is located at river mile 291 on the Illinois Waterway immediately west of the city of Lockport. The lock is 600 ft long by 110 ft wide and has a lift of 39 ft (Figure 138). The lock walls and sills are of concrete masonry. Two submersible vertical lift gates, a guard gate and a service gate, are provided at the upper end of the lock. The lower gates are of miter type. The filling and emptying system is the wall-port type. The lock was completed in 1933 at a total cost of \$2,153,867. Since the original construction, the following major rehabilitation was performed:

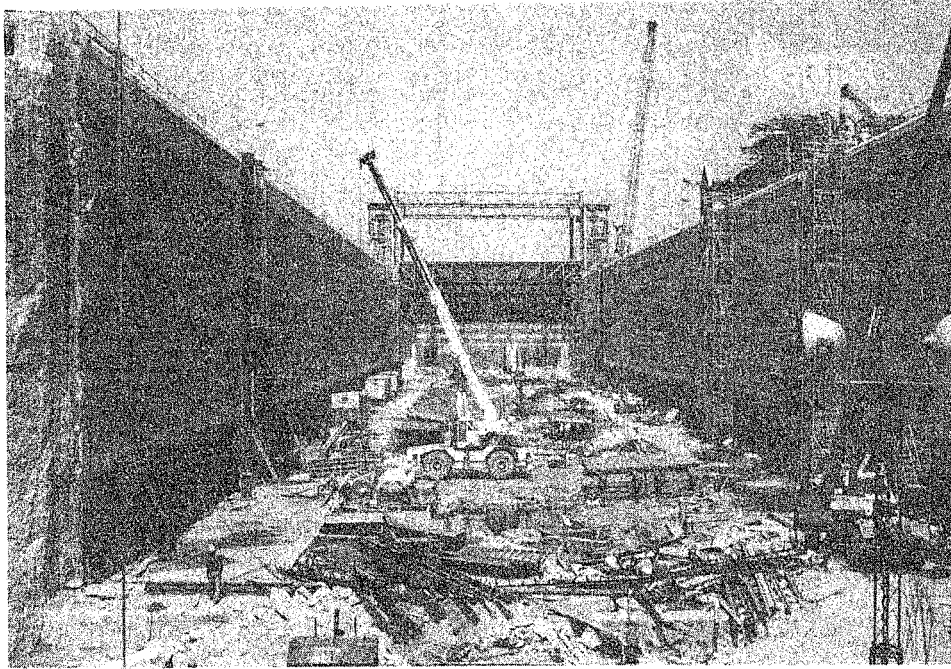
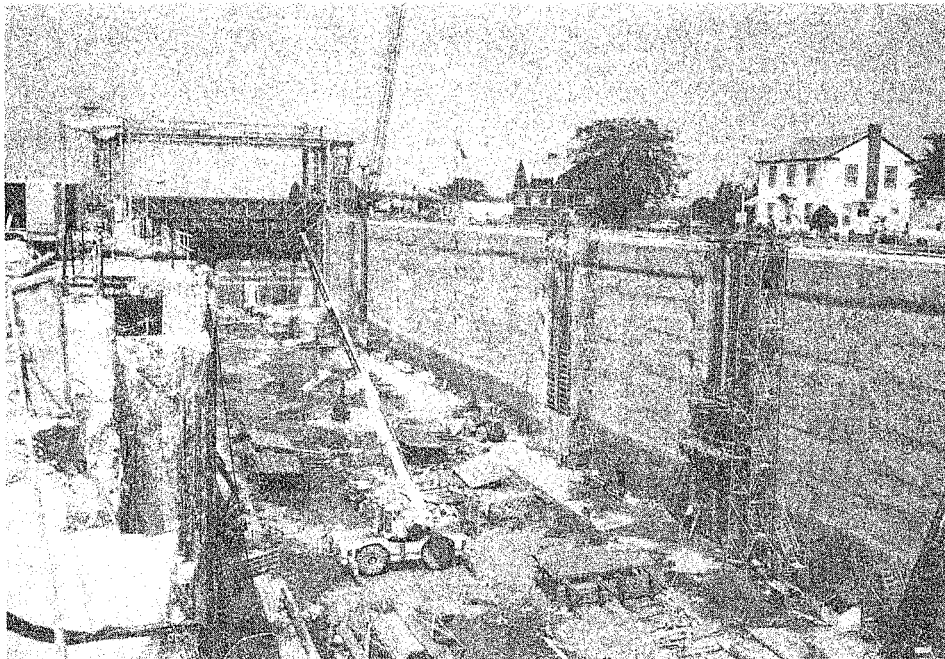
Figure 139. Stage I rehabilitation, Lockport Lock

compared to the Government estimate of \$8.0 million. An abstract of the bids is shown in Appendix A. The major work items under this contract were complete replacement of the lower miter gates and machinery, stabilization of the upper service gate sill, modifications to the upper lift gates, modification of the electrical distribution system, and miscellaneous concrete resurfacing (Figure 139).

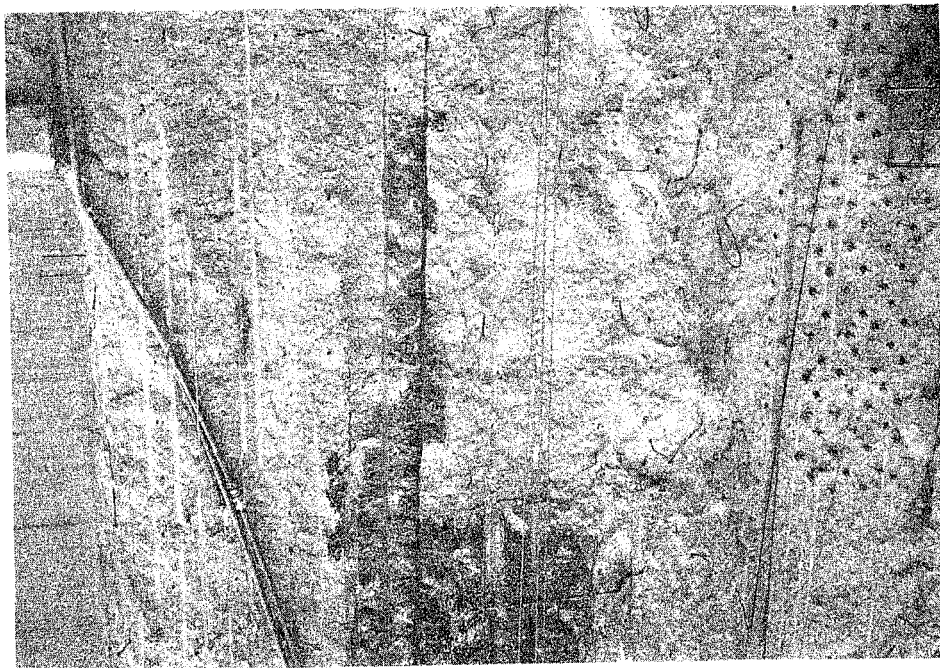
314. In order to complete the necessary concrete removal, the remaining holes along the first drill line were loaded with detonating cord and the fractured concrete removed by blasting (Figure 142). A similar procedure was used for succeeding lines of drill holes. Extensive concrete removal by hand using jackhammers was still required to complete the removal operation. The crack behind the quoin anchorage area became a critical path item since the lock could not be reopened until this problem was resolved. The question was whether to remove the loose piece of concrete entirely or to anchor it in place. Since the cracked section of concrete is loaded in compression with the lock at upper pool, it was concluded that it could be posttensioned to the

Figure 142. Typical surface following concrete removal,  
Lockport Lock

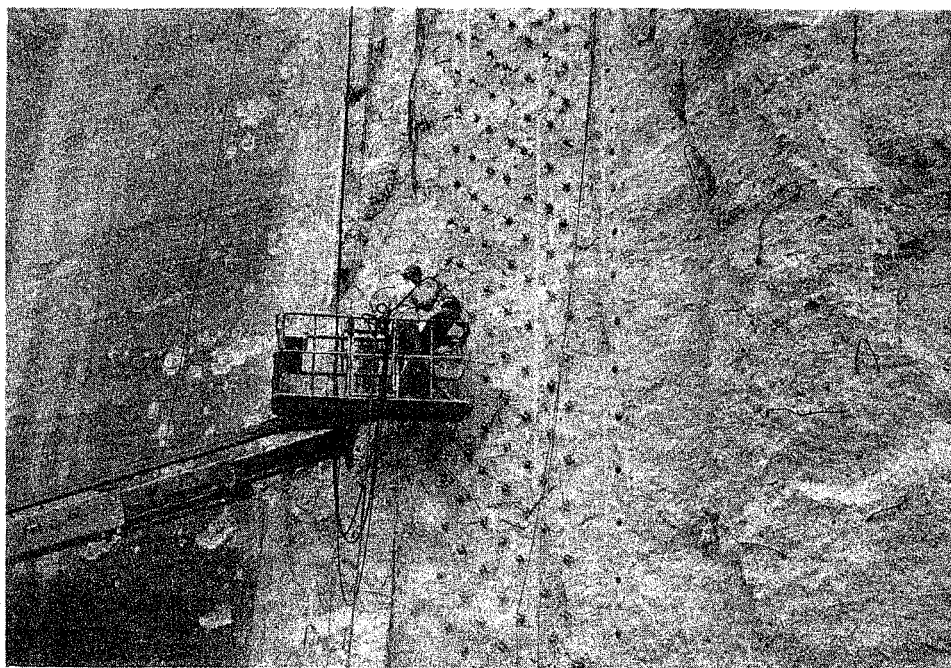
main monolith mass with no loss in structural integrity. Therefore, a number of anchors were installed to strengthen the concrete sections near the miter gate anchorages (Figure 143). Following installation of dowels, gate anchors, and conventional reinforcing (Figure 144), these areas were formed and a concrete overlay was placed over the entire area to seal all internal work. A concrete mixture (Type C) proportioned for a slump of 1 to 4 in., an air content of  $6 \pm 1\frac{1}{2}$  percent, and 4,000-psi compressive strength at 28 days was used in all concrete work with the exception of the upper service gate sill. Concrete mixture proportions for a 1-cu yd batch were as follows:

Figure 143. Rock anchors used to strengthen concrete sections near the miter gate anchorages, Lockport Lock

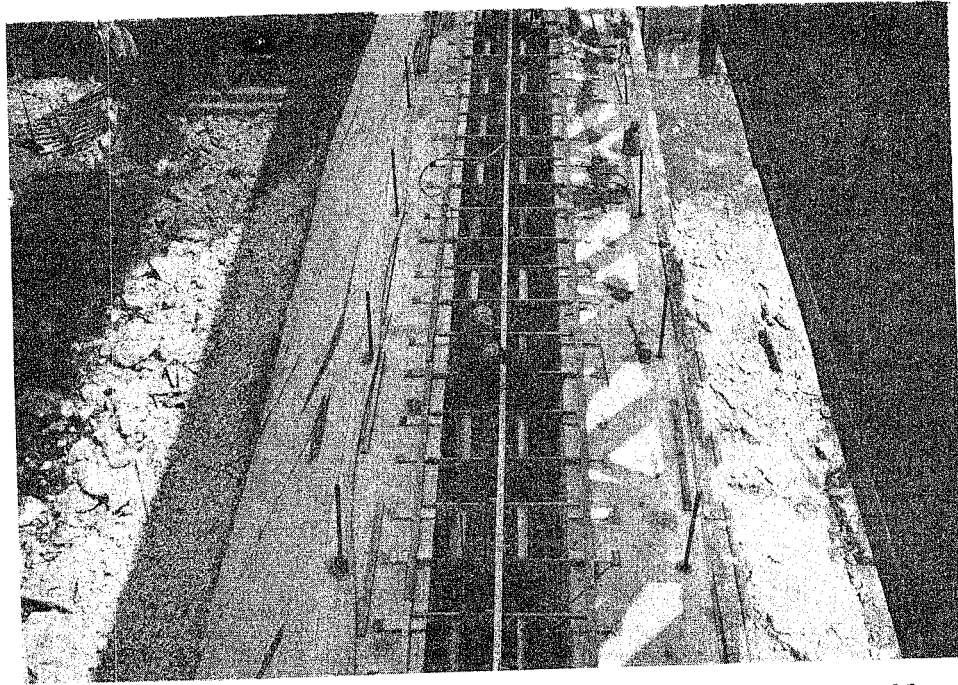
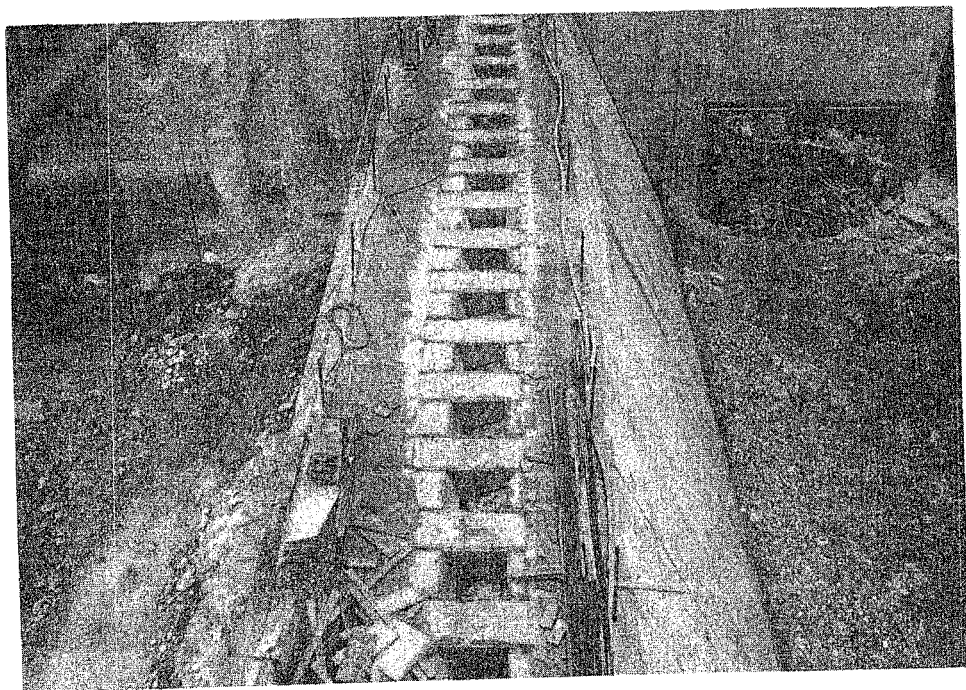
the sill. After reinforcement was installed, blockouts for anchor recesses were formed, and concrete was placed to original grade (Figure 145). A concrete mixture (Type A) proportioned for a slump of 1 to 4 in., an air content of  $6 \pm 1\frac{1}{2}$  percent, and 4,000-psi compressive strength at 7 days age was used in gate stabilization work. Concrete mixture proportions for a 1-cu yd batch were as follows:

a. Anchor recesses formed in top surface of gate sill

b. Completed anchor recesses

Figure 145. Modification of upper service gate sill prior to installation of rock anchors, Lockport Lock

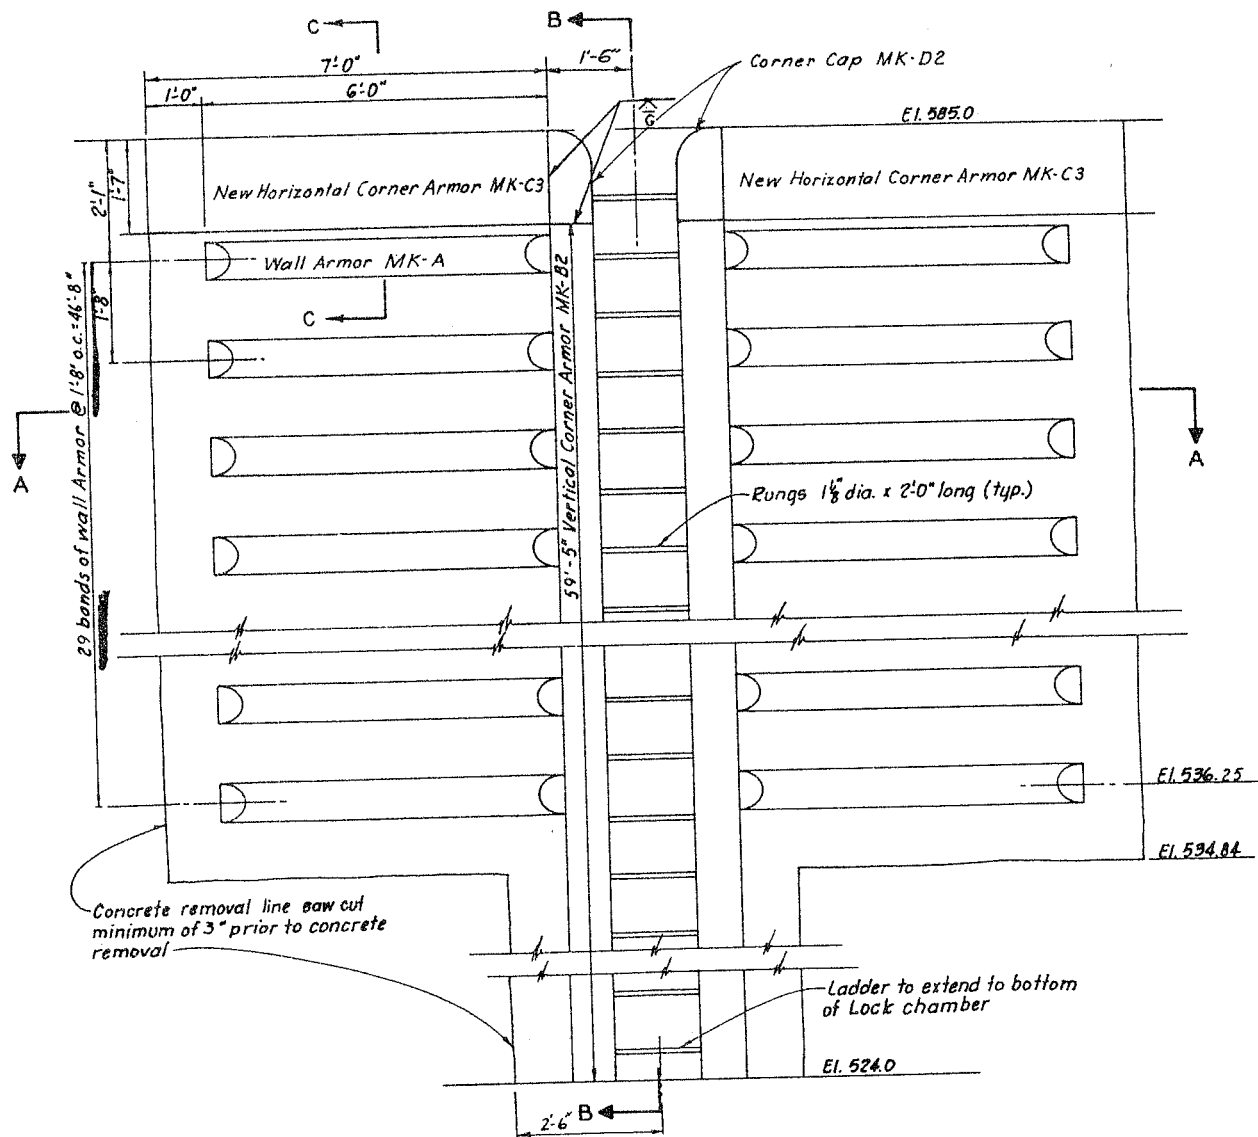
Figure 148. Ladder details, Lockport Lock

321. New exit ladders with protective armor were installed in the lock chamber as shown in Figures 148 through 150. This installation required removal of approximately 150 cu yd of concrete. In most cases, a nominal 14 in. of concrete was removed, except in the immediate vicinity of the ladders and the top corner of the lock wall, where 21 in. of concrete was removed. Concrete removal varied from approximately 50 ft to full face in the lock chamber (61 ft). Concrete removal lines were sawcut to a minimum depth of 3 in. prior to concrete removal. In spite of the sawcut removal line, there was significant overbreak with the explosive blasting used to remove the concrete (Figure 151). The boundaries of these overbreak areas were sawcut to a minimum depth of 3 in., and concrete within these areas was removed by chipping with handheld breakers to a minimum depth of 3 in. (Figure 152). The contractor proposed, and the Corps approved, the use of Weld-Crete as a concrete bonding agent in those overbreak areas in which the replacement concrete was not anchored to the existing wall. The primary factor in selection of this bonding agent was that according to the manufacturer, Larsen Products Corporation, the replacement concrete could be placed up to 10 days after application of the bonding agent with no effect on bond. Thus, the contractor had more than enough time to complete forming of a given area after the bonding agent was applied to the existing concrete.
